Pedestrian Behaviour and the Design of Accessible Rail Crossings

Craig McPherson, Malcolm Daff
Sinclair Knight Merz, Melbourne, Australia

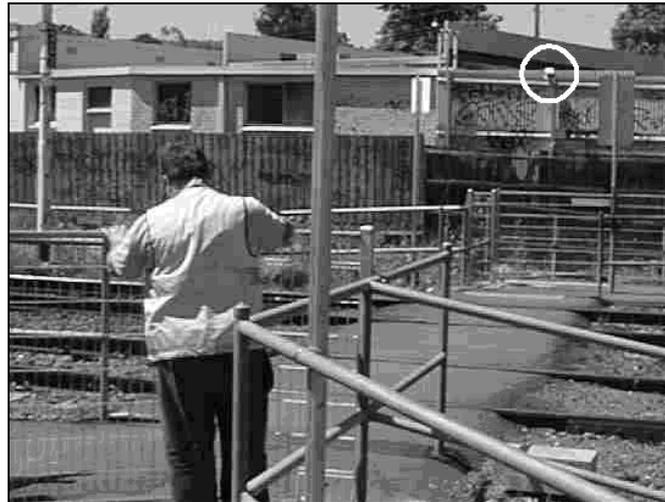
A video camera was mounted on a fence on the south side of the crossing to provide continuous footage of the crossing area (see Figure 7). A number of three-hour segments were recorded on selected weekdays during November and December 1998, including mid-morning periods between approximately 8:00 and 11:00 am, and afternoon peaks between 3:00 and 6:00 pm.

Figure 7: Video surveillance of the crossing

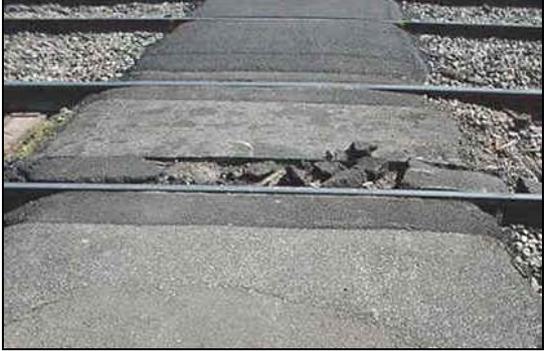
Problem	Example
<p>Uneven crossing surfaces, potholes and flangeway gaps, cause hazards for wheelchair and mobility aid users. Asphalt pavements are prone to deterioration at crossings, particularly in sections immediately adjacent to the rails. The pavement may break up or deform, creating an uneven surface and accentuating the flange gap</p>

<p><i>Asphalt has broken up at this crossing, creating a tripping hazard and obstruction</i></p>
<p>Limited manoeuvring space sometimes inhibits larger wheelchairs and scooters from moving safely through the crossing and accessing emergency escape paths.</p>

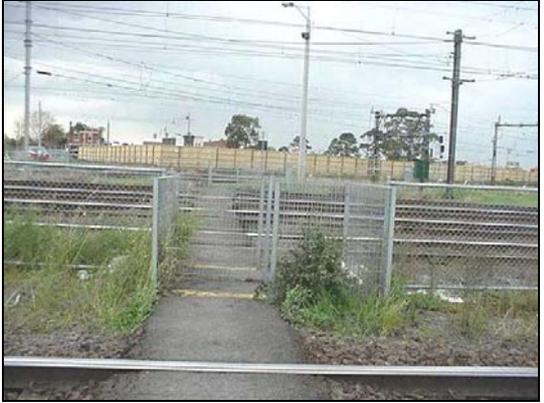
<p><i>This narrow path and fencing allow very little room for manoeuvring scooters</i></p>
<p>Insufficient warning times for slower moving pedestrians.</p>	<p><i>The minimum time between the initial audible warning and arrival of the train in Victoria is 25 seconds. At automatic gated crossings, the warning typically sounds for about 7 seconds before the gate closes. For some slower pedestrians (including wheelchair users, frail elderly pedestrians and vision-impaired pedestrians), this warning time is insufficient to clear the crossing before the gates close.</i></p>

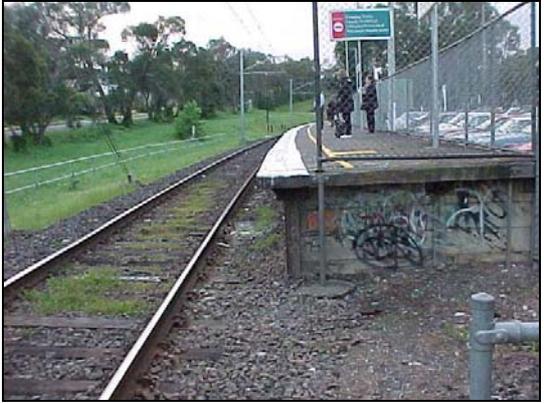
<p>Lack of visual and aural warnings for hearing and vision-impaired pedestrians. At most of the 170 isolated crib crossings in Victoria, there are no visual and aural warnings such as lights and bells. Pedestrians must rely on sighting trains by looking up and down the track, or by listening for the train's approach. Vision and hearing impaired pedestrians and wheelchair users can be disadvantaged in these situations.</p>

<p><i>Visual and aural warnings are particularly important where clear sight lines are obstructed</i></p>

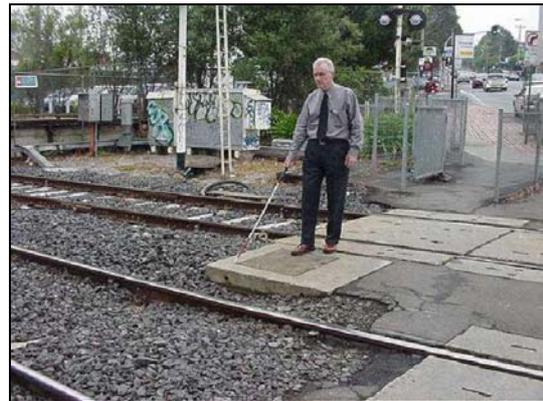
Badly-aligned crossing paths that are not at 90 degrees to the rails may cause navigational problems for vision-impaired users. A particular problem is caused when the openings on each side of the crossing do not line up, possibly causing confusion and straying off the crossing path.

The angle of this crossing would cause significant problems for vision-impaired and blind pedestrians (photo used with permission from Ivan Peterson, Banyule City Council, Melbourne)

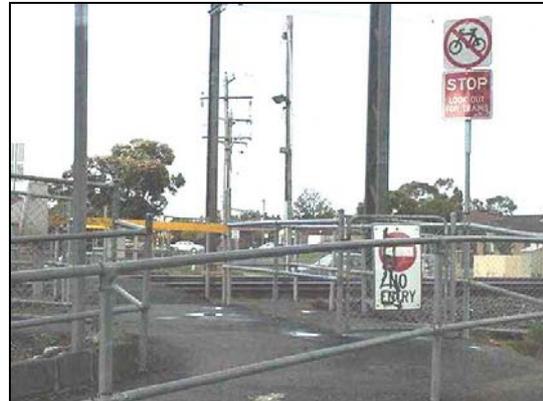
Lack of navigational aids, such as high-visibility lines and tactile indicators. Although most crossings have fencing on either side of the tracks, there are often no other tactile or high-contrast visual aids to assist navigation across the tracks.

Fences and paths are difficult to distinguish at this crossing

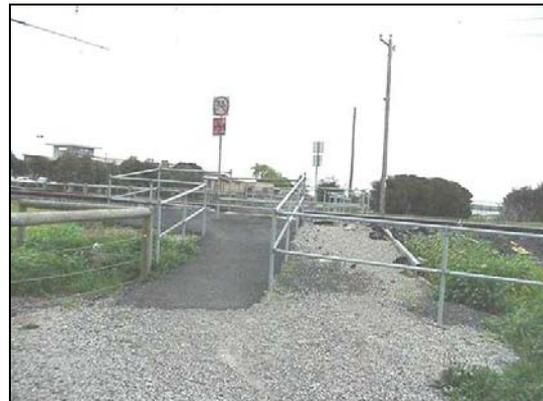
Lack of integration of the crossing with the surrounding footpath and road network. Narrow paths, steep gradients, uneven surfaces and lack of integration with the surrounding pedestrian network may prevent some pedestrians with disabilities using the crossing.

Rough surfaces and steep gradients on the approach to this crossing may make this crossing inaccessible for some pedestrians
