# Driver compliance at railway level crossings

Li-Sian Tey<sup>1,2</sup> and Luis Ferreira<sup>1</sup>

## Abstract

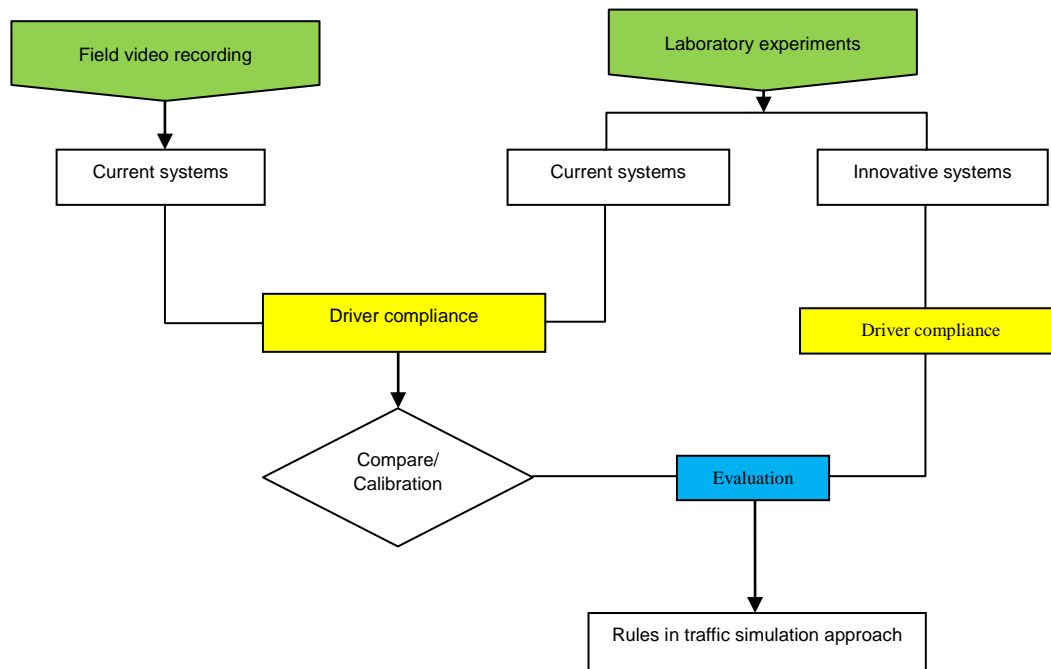
**Figure 1: Driver compliance evaluation with field survey and driving simulator experiments**

The field results reported in this paper are part of a study aimed at developing a methodology to evaluate innovative RLX protection systems from the aspects of engineering considerations and human factors. For engineering evaluations, a few potential systems which would suit the objective of the research were selected as examples using multi-criteria analysis technique (Tey et al., 2009). For the human factor aspect, driver responses towards protection systems were measured both in the field as well as in the laboratory using a driving simulator. One of the important driver responses considered is driver compliance to the protection systems since higher records of violations may indicate a higher possibility of collisions with trains. Figure 1 briefly outlines the interface between the two approaches. The driver compliance rate measured from different types of existing protection systems in the field will be compared to the results of driver compliance from driving simulator experiments in the next stage of the study. Subsequently, driver compliance (and other driver responses) to innovative protection systems will be assessed. Driving simulator experiments have been designed to involve human factors in determining contributing variables of driver behaviour to different types of protection systems. The results can be incorporated into a microscopic traffic simulation approach. The interface of driver behaviour results from the driving simulator into a traffic simulation approach will enable innovative RLX protection systems to be evaluated in laboratory controlled conditions. The output of this study will contribute to the evaluation process of innovative RLX protection systems taking into consideration both engineering and driver behaviour factors.

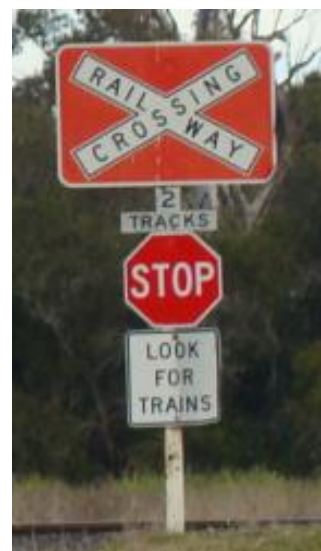
Figure 2: (a) Layout of Site 1; (b) Stop sign at Site 1

Four RLX sites in and around Brisbane were selected, two being passive and two active. Three types of protection systems are used at the four sites: signage, alternately flashing red lights/bell and a half-boom barrier. One of the passive crossings selected (Site 1), is equipped with an approaching train sign (W7-7R), an approaching stop sign (W3-1) and a stop sign at the crossing (Assembly RX-2) complying with MUTCD Part 7 (Standards Australia, 2007) as shown in Figure 2 (a) and (b). This RLX crosses Lane Road at 90 degrees. The roadway is a two-lane two-way road which branches out from a major collector linking towns between Ipswich and Toowoomba with a posted speed limit of 80 km/hr. The crossing is located more than 1km away from the major collector. The train track serves weekly passenger trains between Brisbane and Toowoomba and coal trains to the Port of Brisbane. The second studied site (Site 2) is another passive crossing located at a local residential street (Videroni Street), approximately 250m away from a major local street (Stafford Street). It crosses Videroni Street at 90 degrees. As shown in the schematic layout in Figure 3 (a), there is a row of approximately 30 residential units from the crossing to the cul-the-sac. Opposite this row of units is a horse racing club. On the other side of the crossing there are two rows of residential units. The crossing is equipped with an approaching train sign (W7-7R), an approaching stop sign (W3-1) and a stop sign (as show in Figure 3 (b)) complying with MUTCD Part 7 (Standards Australia, 2007). The train track serves mainly a tourist train and occasionally coal trains travelling between Swanbank Power Station and the Port of Brisbane. Two different types of stop signs were observed at Site 1 and 2.

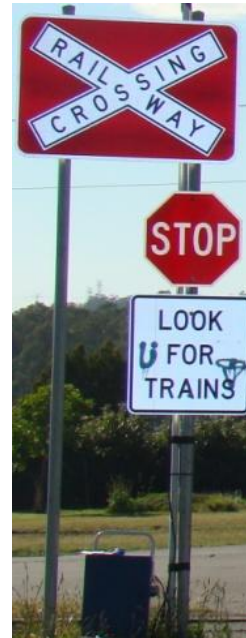
**Figure 3: (a) Layout of Site 2; (b) Stop sign at Site 2**

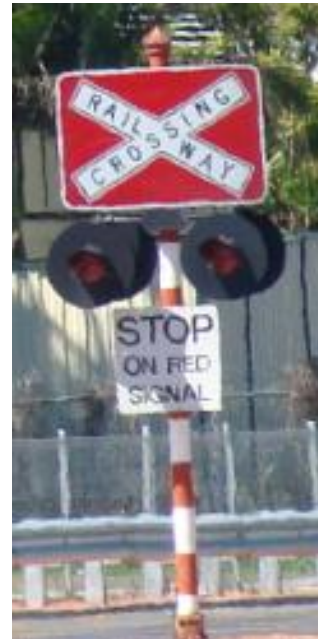
**Figure 4: (a) Layout of Site 3; (b) Flashing light at Site 3**

The other two study sites were active crossings. The crossing at Site 3 crosses Thomas Street at 90 degrees (as shown in the schematic layout in Figure 4 (a)). Thomas Street is a major two-lane two-way local street. The crossing is located approximately 400 metres away from the adjacent T-junction. Site 3 is equipped with a flashing red light and ringing bell. The flashing red light signal as shown in Figure 4 (b) consists of twin red round lights arranged horizontally and equipped to flash alternately. The train track serves mainly for holiday/tourist trains and occasionally for coal trains travelling between Swanbank Power Station and the Port of Brisbane. Site 4 is equipped with flashing red lights, a ringing bell and supplemented by a half-boom barrier (as shown in Figure 5 (a)). As the RLX protection system detects an approaching train, the flashing red signal and the bell are activated, followed 7-8 seconds later by the boom barrier, which starts to descent from its upright position to a horizontal position in approximately 8 seconds, blocking the traffic from entering the crossing. After the train passes the crossing, the boom barrier lifts gradually to its original vertical position in approximately 10-12 seconds; followed by deactivation of the flashing lights and bell approximately 0-2 seconds later. The train track crosses at 45 degrees a four-lane two-way local major road (Samford Road) with a median strip as shown in Figure 5 (b). The crossing is located approximately 500 metres from the adjacent signalised T-junction. The train track is part of the Brisbane city passenger train network that operates daily. The characteristics of the four study sites are summarised in Table 1. Posted speed limits at all four study sites are from 50 to 70 km/hr. The three protection systems described at the four sites are the most commonly used at RLXs in Australia.

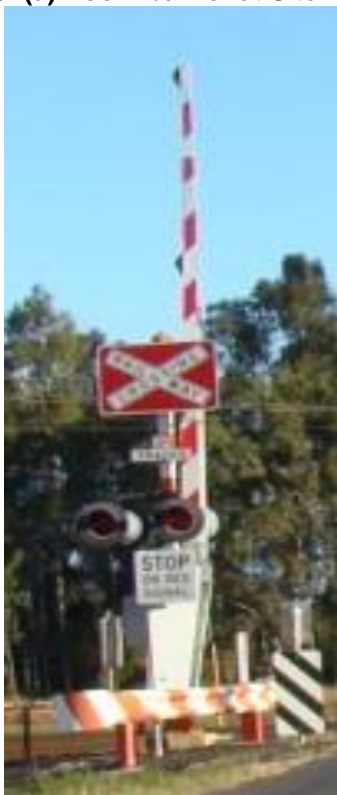
**Figure 5: (a) Boom barrier at Site 4; (b) Layout of Site 4**

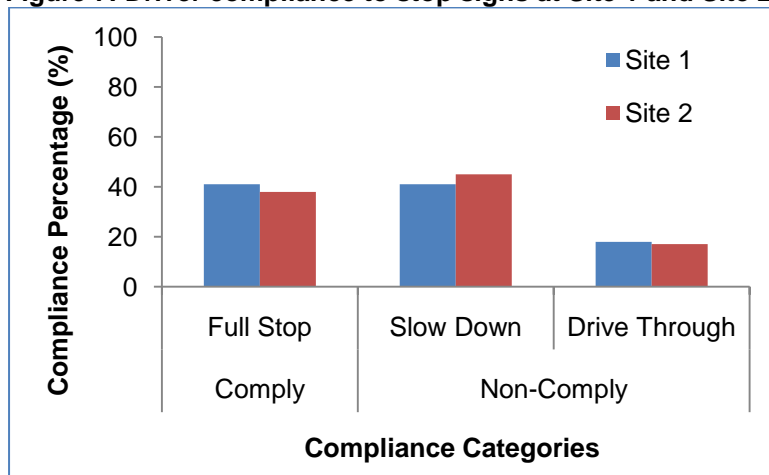
**Figure 7: Driver compliance to stop signs at Site 1 and Site 2**

At Site 1, a total of 66 vehicles were recorded in two days. The non-compliance behaviours were observed and sub-categorised to 'Slow Down' (reduced speed without fully stopping) or 'Drive Through' (neither fully stopping nor reducing speed). These sub-categories could indicate in detail the drivers' behaviour. Figure 7 shows the compliance percentage of the motorists to stop signs at Site 1 and 2. More than half (59%) of the drivers did not fully stop. Nevertheless, the majority (41%) of this non-compliance group slowed down before crossing the tracks. Similar results were observed at Site 2 where a total of 71 vehicles were recorded in two days. More than half (62%) of the drivers did not fully stop but the majority (45%) of this non-compliance group slowed down before crossing the tracks. It should be highlighted that similar compliance trends (stop, slow down and drive through) at Site 1 and 2 were observed, although the types of stop signs and characteristics of the crossings (i.e., numbers of tracks, land use, roadway hierarchy, visibility, etc.) are different. A study by Ward and Wilde (1996) suggested that 'visibility' would not significantly affect driver behaviour as drivers tend to maintain their safety margin regardless of improvement of visibility. Their study showed that improvement of lateral sight distances resulted in an upstream shift towards longer search durations and a tendency towards faster approach speeds, but failed to produce a calculated net safety benefit. Comparison of driver compliance results between Site 1 and 2 from this current study supports the notion that visibility might not influence driver behaviour at passive crossings because Site 1 had better visibility (no visibility restriction by building) compared to Site 2. Even with the introduction of advance warning signage, there was no evidence of an increased number of vehicles coming to a full stop at the passive crossings (Ward and Wilde, 1995). Ignoring stop signs may lead to a crash, as human have been found unable to accurately judge the speed and distance of an oncoming train (Cohn and Nguyen, 2003; Cooper and Ragland, 2008).

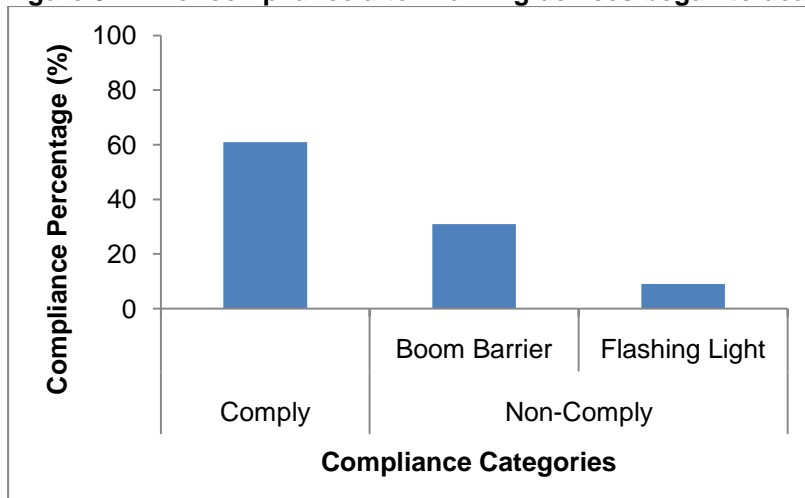
**Figure 9: Driver compliance after warning devices began to deactivate at Site 4**

For the total of 157 vehicles that complied with the boom barrier at Site 4, their compliance behaviour after the warning devices had been deactivated was investigated. Once the train was detected leaving the crossing, the warning devices would be deactivated, first by lifting of the boom barrier to its vertical position taking approximately 10-12 seconds, followed by cessation of the flashing lights after 0-2 seconds. Thus, vehicles waiting at the crossing for the train to pass were investigated for their compliance with the warning devices and categorised into 'Comply' (moved after both boom barrier and flashing light had deactivated); 'Boom barrier' (moved before boom barrier fully lifted); or 'Flashing Light' (moved after boom barrier fully lifted, but before lights had stopped flashing). This scenario was investigated because it is important for 'second train collisions'. Figure 9 shows that 61% of the drivers complied, 31% of the drivers crossed before the boom barrier was fully lifted, while 9% of the drivers crossed before the flashing light had stopped. These violations indicate the possibility of intentional action is high rather than due to unintended error.
